**METCOA RESTART SITE  
QUARTERLY REPORT  
JULY TO SEPTEMBER 30, 1994**

**H & A of New York  
Rochester, New York**

**Xerox Corporation  
Webster, New York**

**File No. 70434-042  
December 1994**

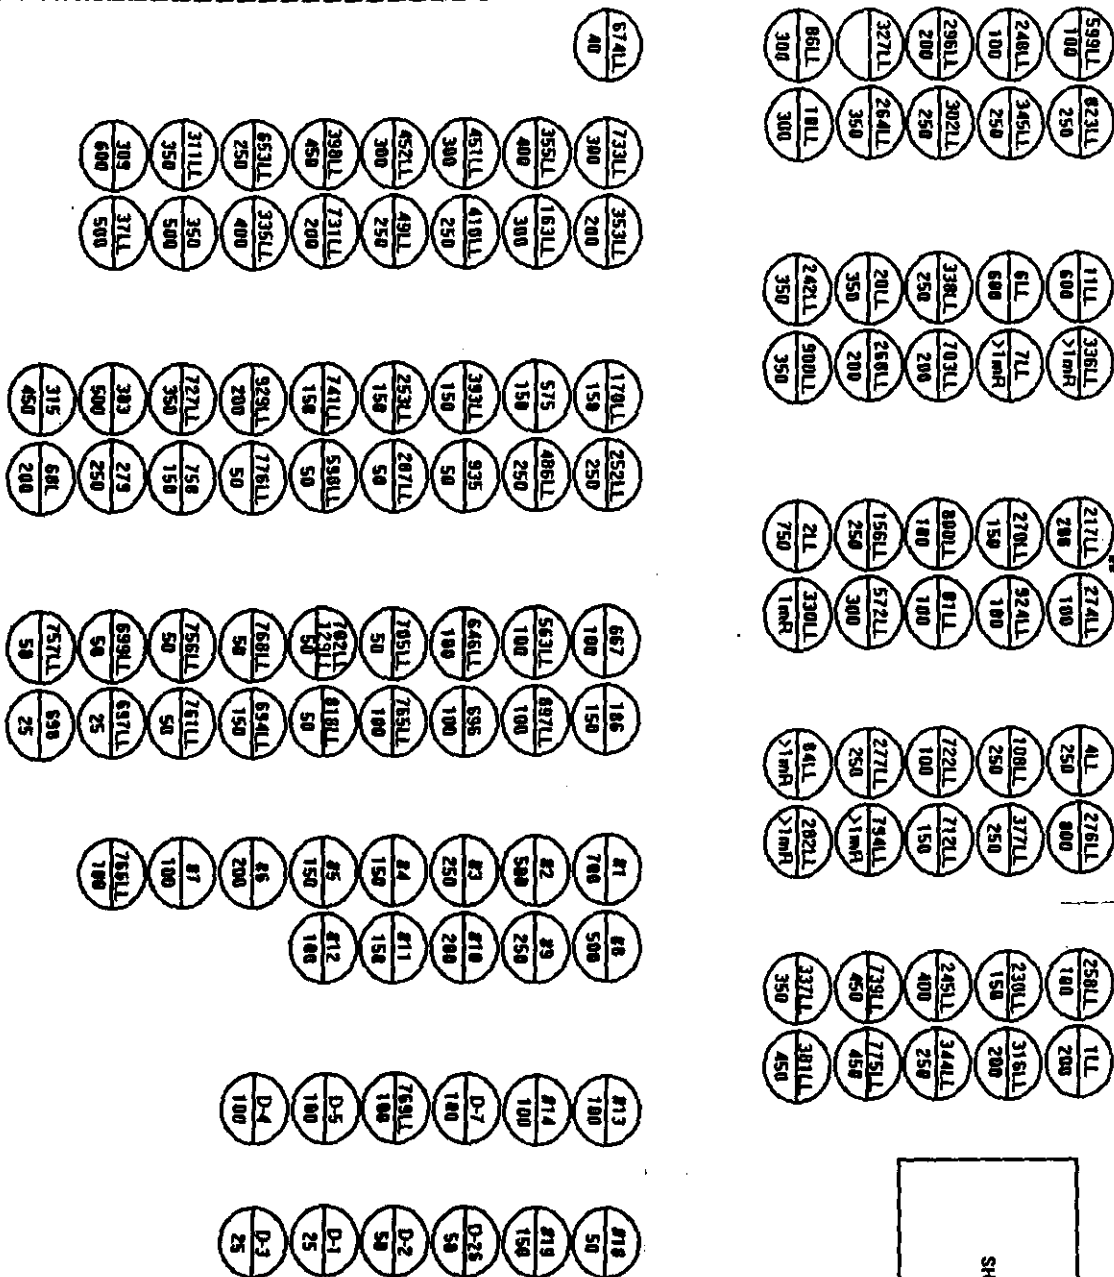
FENCED AREA INSTALLED  
SEPTEMBER 1994

Radioactivity at the site was measured by using a Victoreen, Inc. Model 190 radiation monitor equipped with a 489-110D pancake probe. Two areas of elevated radioactivity, consistent with those observed by EPA, were detected outside the fenced perimeter of the site. The boundaries of the new fence enclosures were set where the radioactivity was less than two times the background level. Chain link type mesh steel fencing topped with barbed wire was installed at the areas identified as shown on Figure 1.

The first area of elevated radioactivity was located along the northwest corner of the fenced perimeter. A maximum reading of 60  $\mu$ rad/hr was detected in this area of the site on 16 September 1994. A trapezoidal fence enclosure of 40 total linear feet was installed by Carlucci on 16 September 1994 to restrict access to this area. Each leg of the trapezoidal fence was 10 feet in length and the base was 20 feet in length. The approximate location of this fence enclosure is shown on the attached figure. The endposts of this new fence were installed flush with the existing perimeter fence posts in order to prevent access into the site. An opening was cut in the former perimeter fencing in the newly enclosed area so as to provide access from inside the site to the new perimeter fence.

The second area of elevated radioactivity was located along the southern portion of the fence perimeter. A maximum reading of 95  $\mu$ rad/hr was measured in this area of the site on 16 September 1994. A trapezoidal fence enclosure of 60 total linear feet was installed by Carlucci on 18 September to restrict access to the elevated readings of radioactivity in this area. The most eastern leg of the trapezoidal fence was 20 feet in length, the opposite leg was 30 feet in length, and the base of the trapezoidal fence was 10 feet in length. The approximate location of the second fence enclosure is also shown on the attached figure. The endposts of this new fence were installed flush with the existing perimeter fence posts in order
